A Study on the Evaluation of Physical Facilities (Infrastructures) and Processing Operational Units of Major Slaughterhouses and Meat Retail Shops in Jammu Districts of Jammu and Kashmir

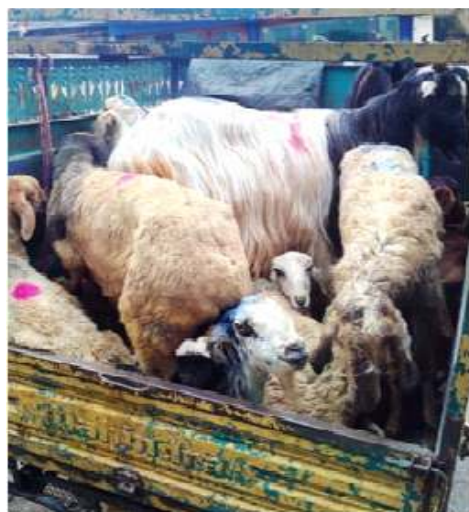
Fig. 1. Transport of animal in stressed condition for slaughtering

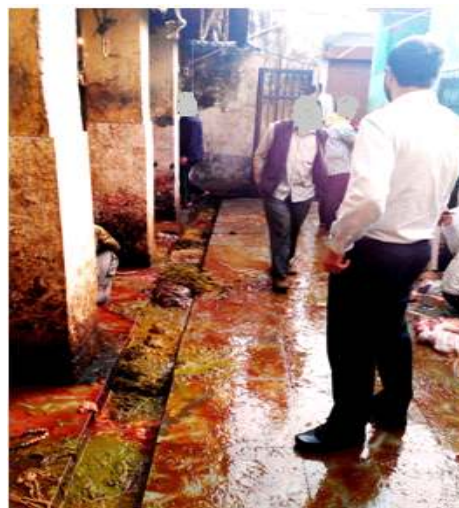
Fig. 2. Slaughter hall of different size lacking important sections

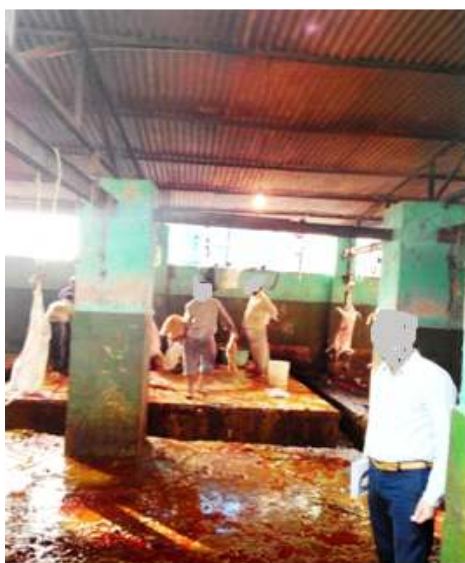
Fig. 3. Unhygienic condition slaughter hall lacking processing units

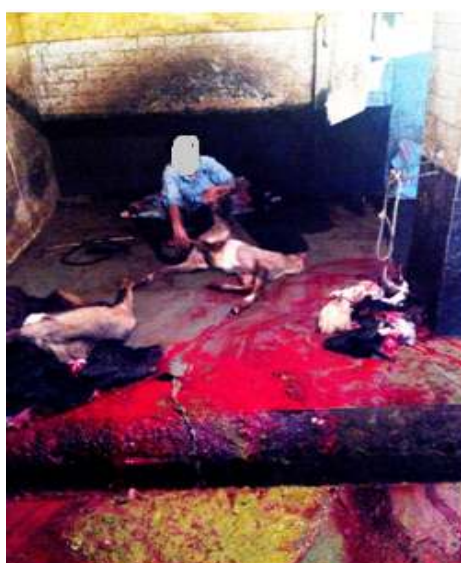
An analysis of Table 4 unveils that the hall at slaughter houses had cemented walls, tin roofing and concrete cemented floors. It was observed that the walls and flooring were in poor state in slaughter halls. The plaster was coming out from walls, many cracks and holes in the walls as well as roofs were visible. The gradient for drainage waste water was not proper. Also, there was no separation between clean and dirty section and thus incidences of reversal, intersection or overlapping between the live animals and meat, and between meat and by products or waste were frequently observed which undermined the whole concept of hygienic meat production.

Fig. 4. Unclean Walls and floor of slaughter halls

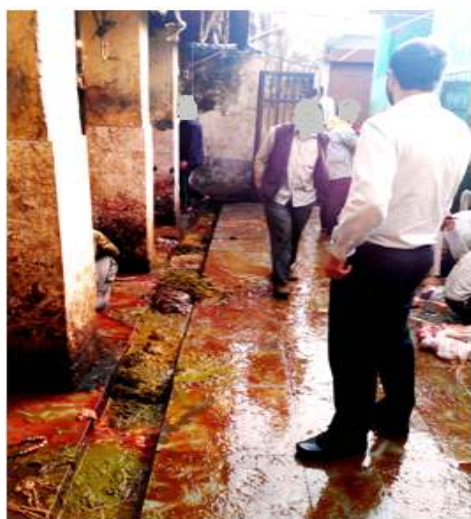
artificial light was noticed in slaughter halls. There was no system for disposal of slaughter waste and only one slaughter house had land available for future expansion.

Fig. 5. Slaughter hall lacking proper drainage slope and waste disposal system

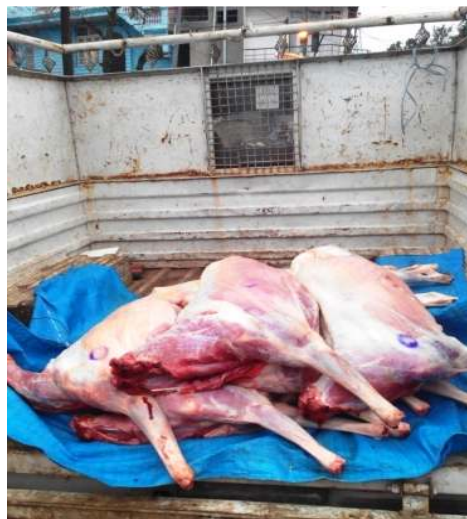
Fig. 6. Uncovered transport of carcass

It was observed that after slaughtering and dressing of sheep and goat, the retailer transported the dressed carcasses to their respective shops for sale. An analysis of Table 13 displays that majority of retailers (53.30%) were using three wheeler for transportation of carcass from slaughterhouses to retail meat shops, whereas 23.30%, 16.70% and 6.70% of retailers were using two wheelers, van and cart for transportation of carcasses. Table 13 further explains that care was taken to cover the carcasses while transportation. Considerable proportions of respondents (60%) were using cloths to cover the carcasses. It was further observed that though carcasses were covered, it was not effectively covered and chance of hazards of chemical, physical and biological contamination was high. Stacking of carcasses one over the other increased the chance of cross contamination. The vehicles used for transportation were dirty and ill designed for transportation of carcasses/meat.
