Studies on Soil Physical Quality of PT Coal Mine Reclamation Land, Sumber Bara Abadi, Kutai Kartanegara Regency, Indonesia

This research aims to determine the characteristics of the physical properties of the soil and assess the physical quality of the soil on coal mine reclaimed land as outlined in the soil physical quality index (IKFT).

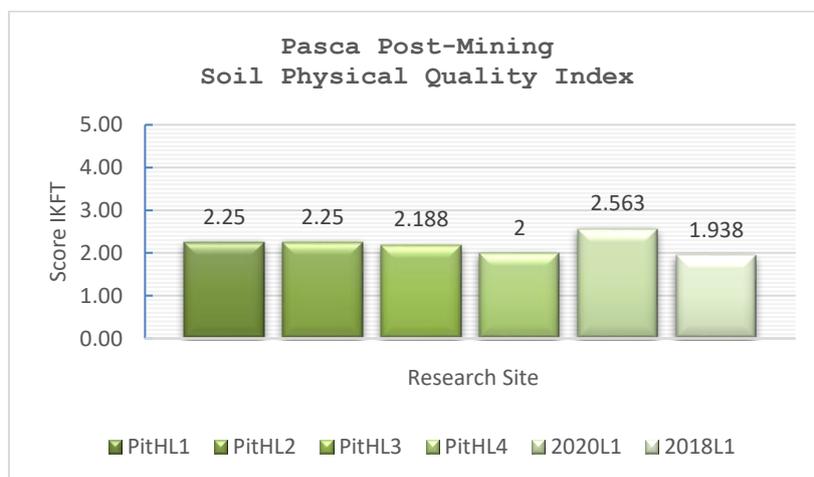
Fig. 1. Soil physical quality index graph

Good quality can help soil function as a medium for plant growth, regulate and save water, and support a healthy environment. Good soil quality is a soil condition that has good physical, chemical, and biological properties as well as high and sustainable productivity. To illustrate the condition of soil quality on post-mining reclamation land, the following is a graph of the results of calculating the soil physical quality index (Fig. 1).

Quality index of physical properties on coal mine reclaimed land, especially in this study, the physical properties of soil on coal mine reclaimed land have a moderate to quite high physical quality index. However, some parameters have low values (<2). Slightly high soil quality is found at research locations PitHL2, PitHL3, and 2020L1, while moderate soil quality is found at

locations PithL1, PitHL4, and 2018L1. The total area of reclaimed land is 12.18 Ha, with the area of land with rather high soil quality being 6.97 Ha or 57% of the total land area, and the area of land with moderate soil quality being 5.22 Ha or 43% of the total land area which is the subject of research. The factors that influence the soil physical quality index will be explained further, namely:
